SURFACE GEOLOGY ALONG THE ROUTE OF THE PROPOSED DANDENONG VALLEY TRUNK SEWER

(Report for the Melbourne and Metropolitan
Board of Works)

A. M. COONEY
17th May, 1973

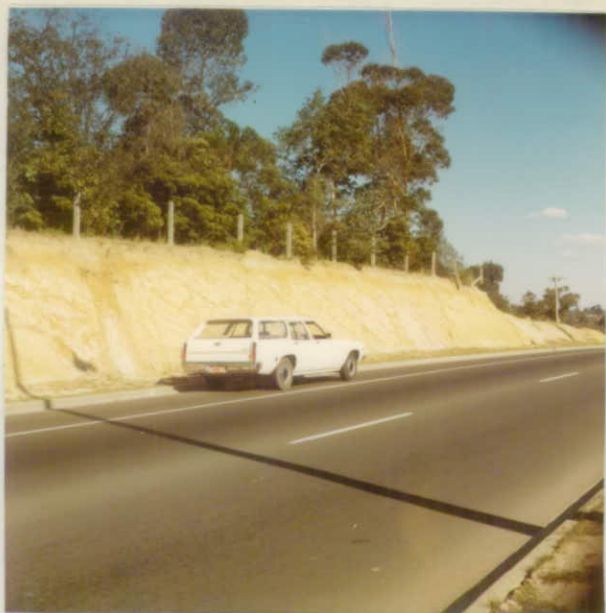
PHOTOGRAPH 1

Outcrop of Anderson Creek Formation in Springvale Rd, 350m south of Highbury Rd:- massive siltstones with very thin sandstone bands. Apparent dip is to the south (right)

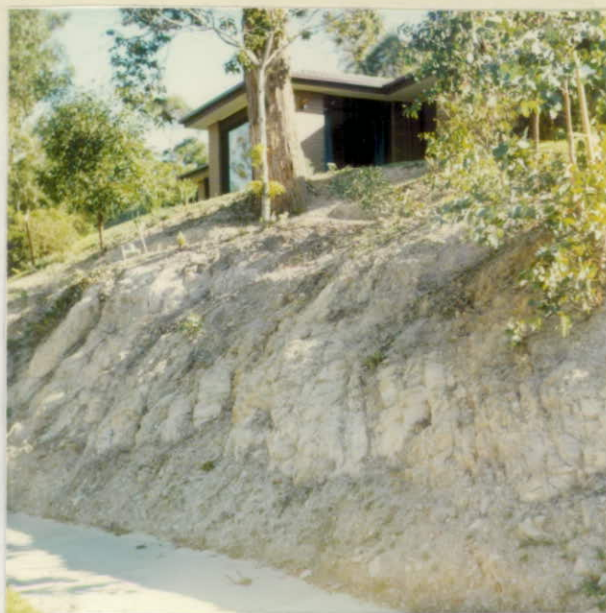
PHOTOGRAPH 2

Outcrop of Anderson Creek Formation in Padua Ct Vermont:- massive sandstone (greywacke) dipping steeply west (right)

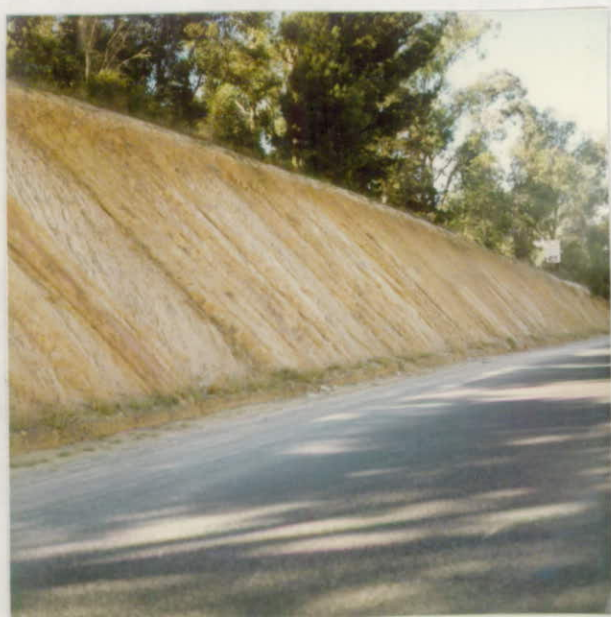
PHOTOGRAPH 3

Outcrop of Dargile Formation in High Street Rd just west of Nortons Lane:- interbedded siltstones (white) and sandstones (brown) dipping east (right)

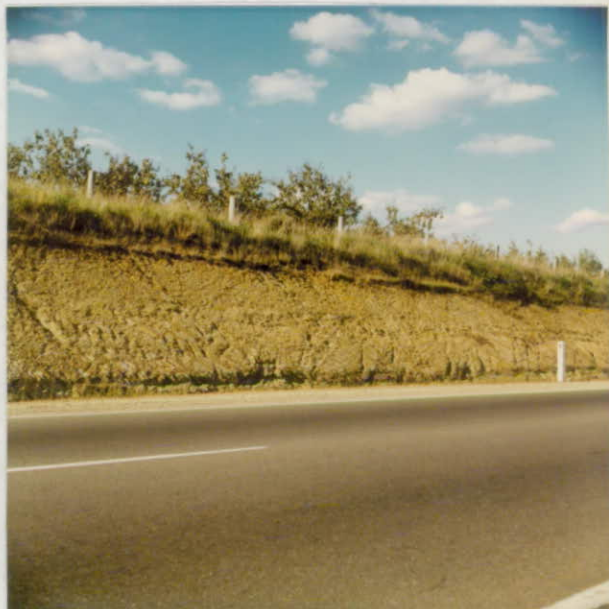
PHOTOGRAPH 4

Outcrop of Humevale Formation on Burwood Highway, 350m west of Stud Road:- mudstones dipping east (right)

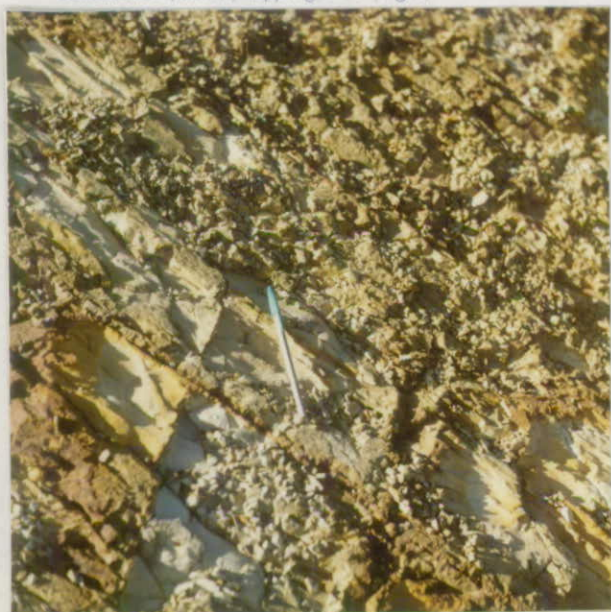
PHOTOGRAPH 5

Location as for photo 4:- typical starchy weathering of Humevale Formation mudstone.

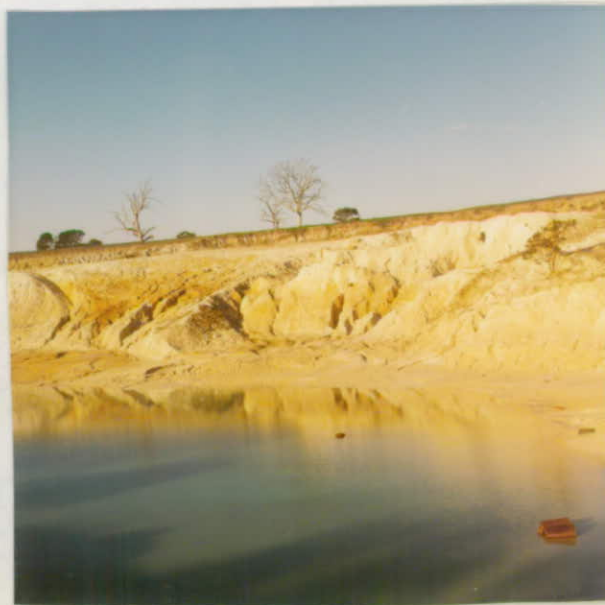
PHOTOGRAPH 6

Weathered Lysterfield granodiorite exposed in Newbolds Quarry, Hallam:- the 30 ft quarry face is clay with some quartz grains. The material has little strength.

1) The most intensely weathered rock is the Lysterfield Granodiorite which crops out near Dandenong as clay (Photo 6). Such intense weathering (Zone 1A) can occur to appreciable depths. For example, test drilling for the foundations of the SEC Dandenong office block penetrated 16.7m of clayey material and 10.6m of weathered granodiorite without encountering any fresh rock. One of the bores in the current MMBW drilling for the DVTS had a similar intersection near the Dandenong-Melbourne Railway line. Less advanced weathering can be seen in the bed of the Dandenong Ck west of Hammond Rd. Here the rock is still obviously granodiorite but it has weathered to the extent that shallow holes can be dug in it relatively easily with a geological pick (Zone 2).
